COMPLETION REPORT  
ST. LAWRENCE RIVER REMEDIATION PROJECT

VOLUME 1 OF 2: 2009 REMEDIAL ACTION

June 2010

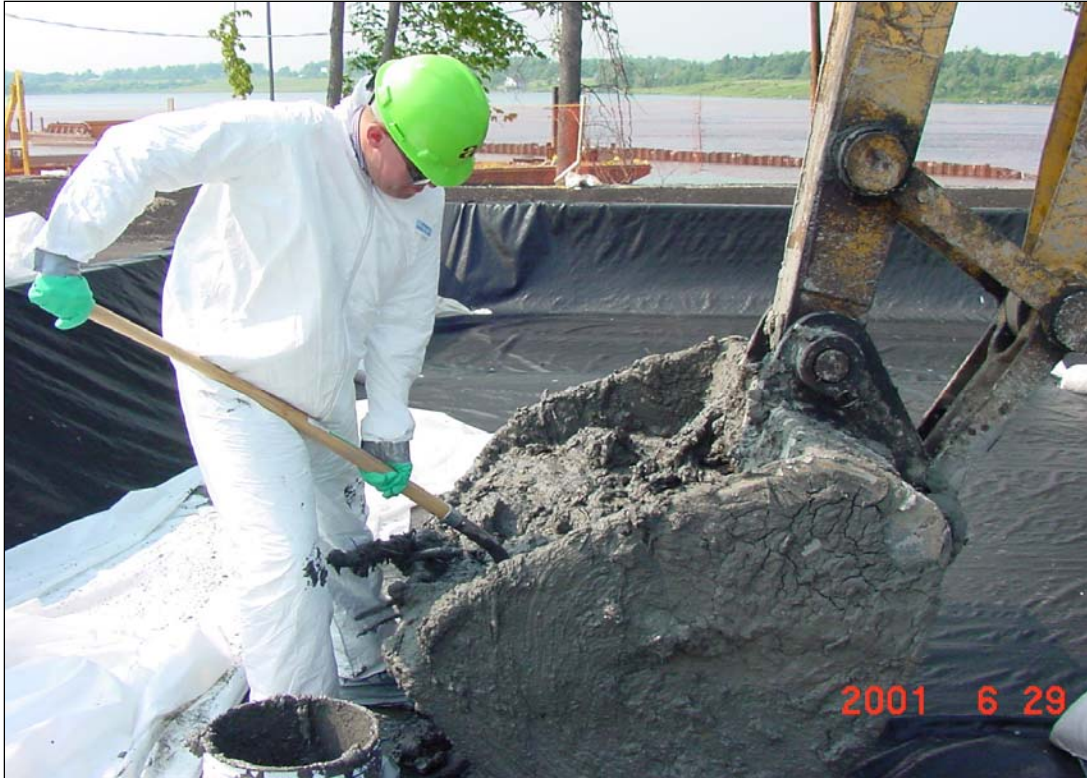
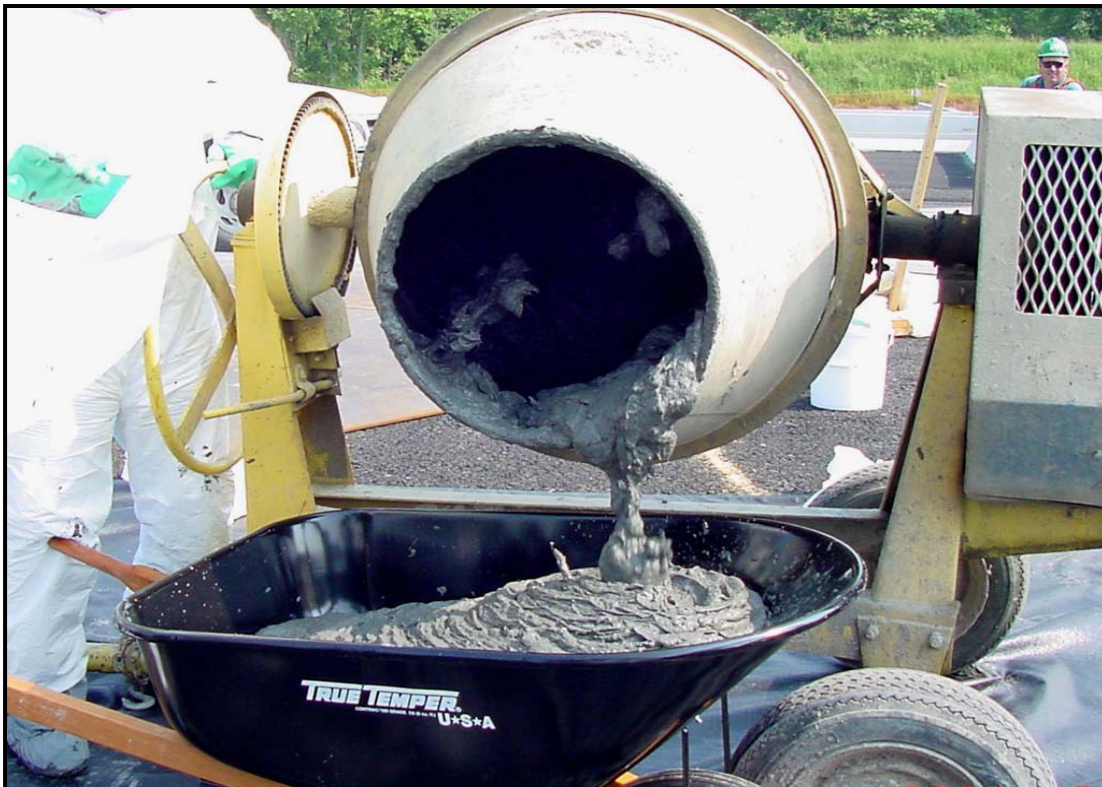
**Figure 3-32**  
**Composite Sampling Methods**

The resulting “characterization” sample was sent to an offsite laboratory for PCB analysis, and the destination of the material was then decided based on the sample results. A large number of split samples were collected from the characterization samples by DEC and EPA. When this occurred, the highest sample result among the split samples determined the ultimate disposition of the material. It is also important to note that stabilization was conducted after the stockpile characterization samples had been collected. Characterization samples were not collected from stabilized sediment.

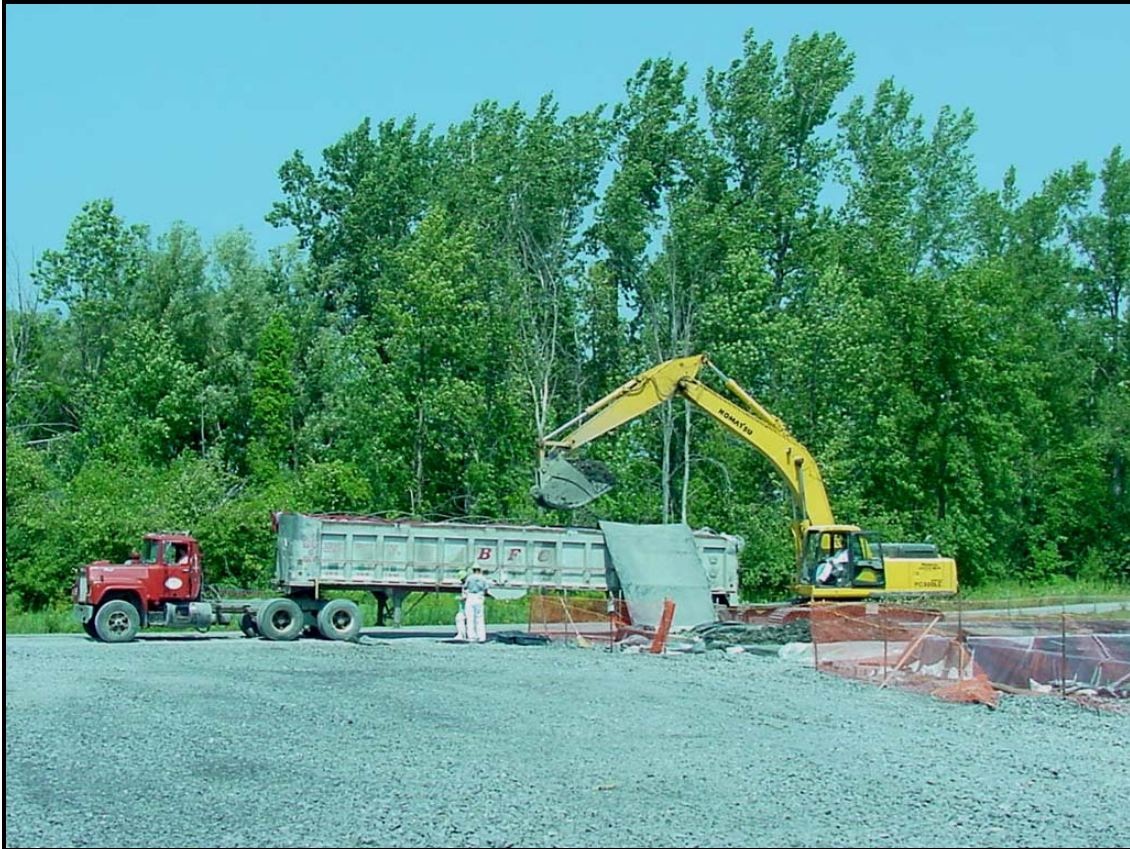
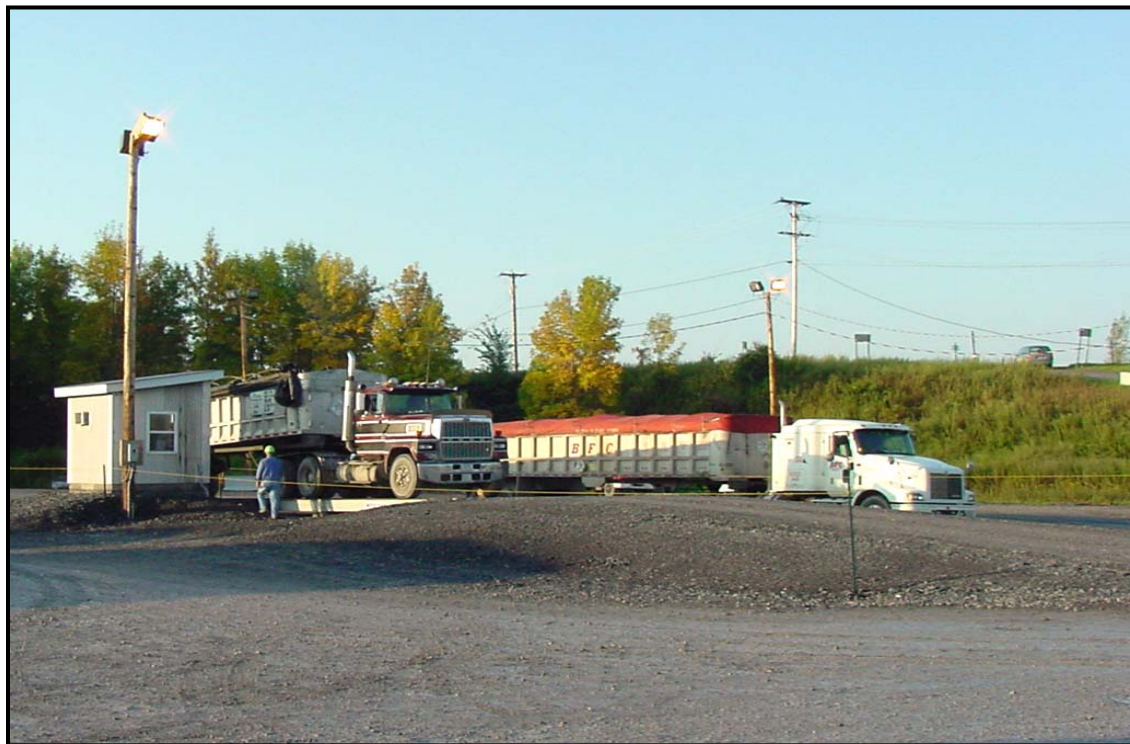
**Figure 3-33**  
**Offsite Shipment of Stabilized Sediment to Model City**

Stockpiles of material yielding characterization samples with PCB concentrations less than 50 ppm were sent to the onsite landfill for disposal. These sediments were stabilized in the drying bed or sediment pen prior to transport to the landfill. Stockpiles of material with PCBs equal to or greater than 50 ppm were sent for offsite disposal at ChemWaste’s Model City facility near Buffalo, New York, a TSCA-approved landfill. These sediments were also stabilized prior to loading into trucks for offsite shipment (Figure 3-33). Further discussion of sediment stabilization for sediments shown to have >500 ppm PCBs is discussed below.

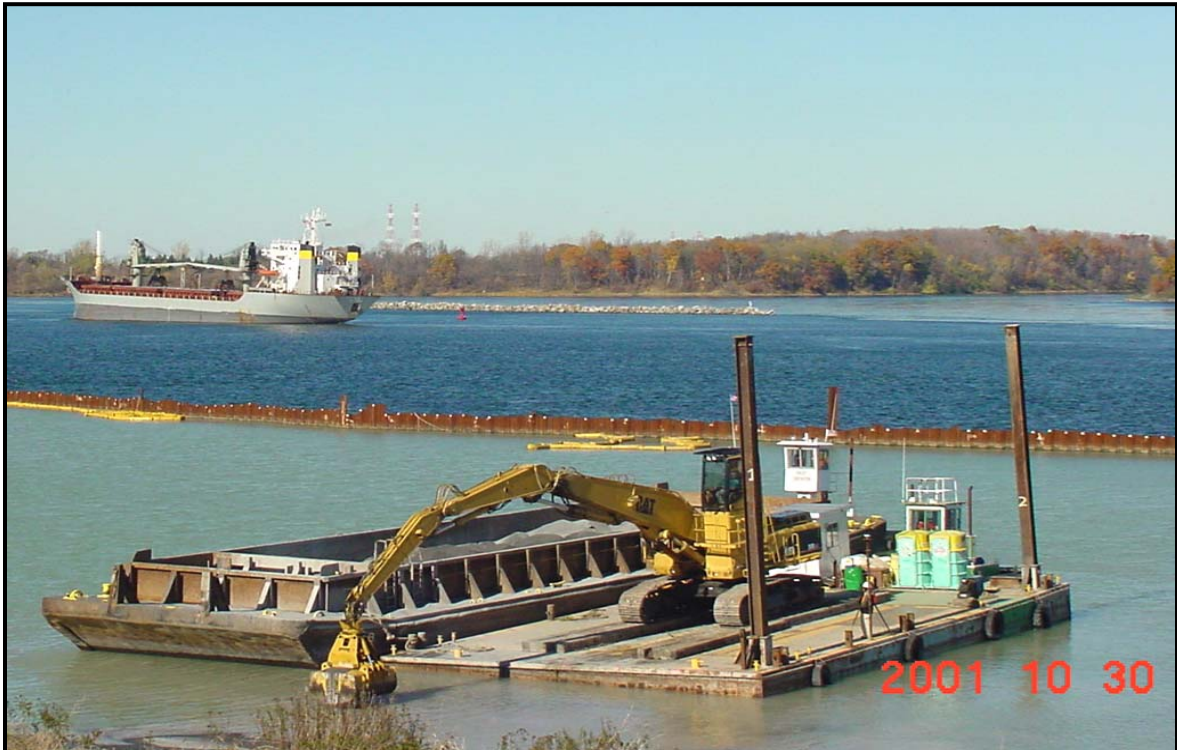
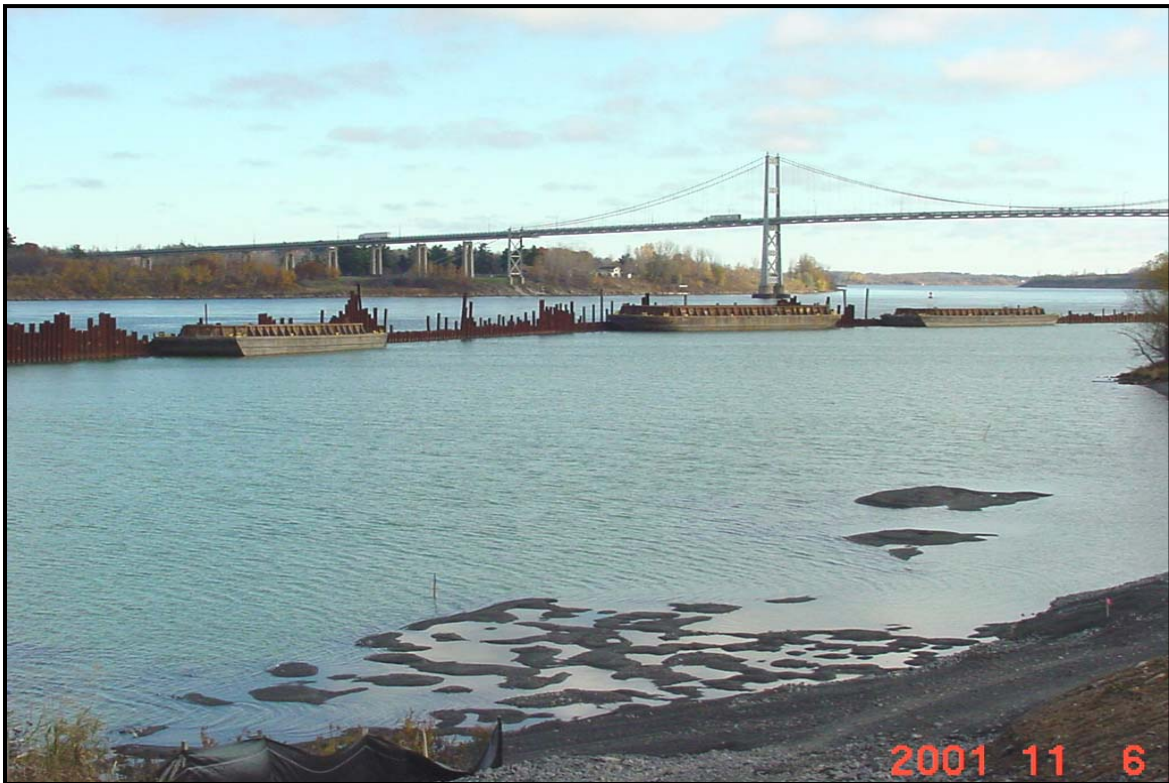
**Figure 3-38**  
**Capping Operations and As-Built Appearance of Capped Cells**

Approximately 6,717 tons of gravel were used in capping the designated area. Using a conversion factor of 1.5 tons per cubic yard, this is equivalent to 4,478 yd<sup>3</sup> of material. Daily bucket-log counts using a conservative value of 2.15 yd<sup>3</sup> per bucket documented placement of 4,059 yd<sup>3</sup> of material with the Cat 350 over an area of approximately 47,240 ft<sup>2</sup>. The remainder of the material was placed on cells C-86, C-87, C-73, C74 and C-75 from shore using an excavator.

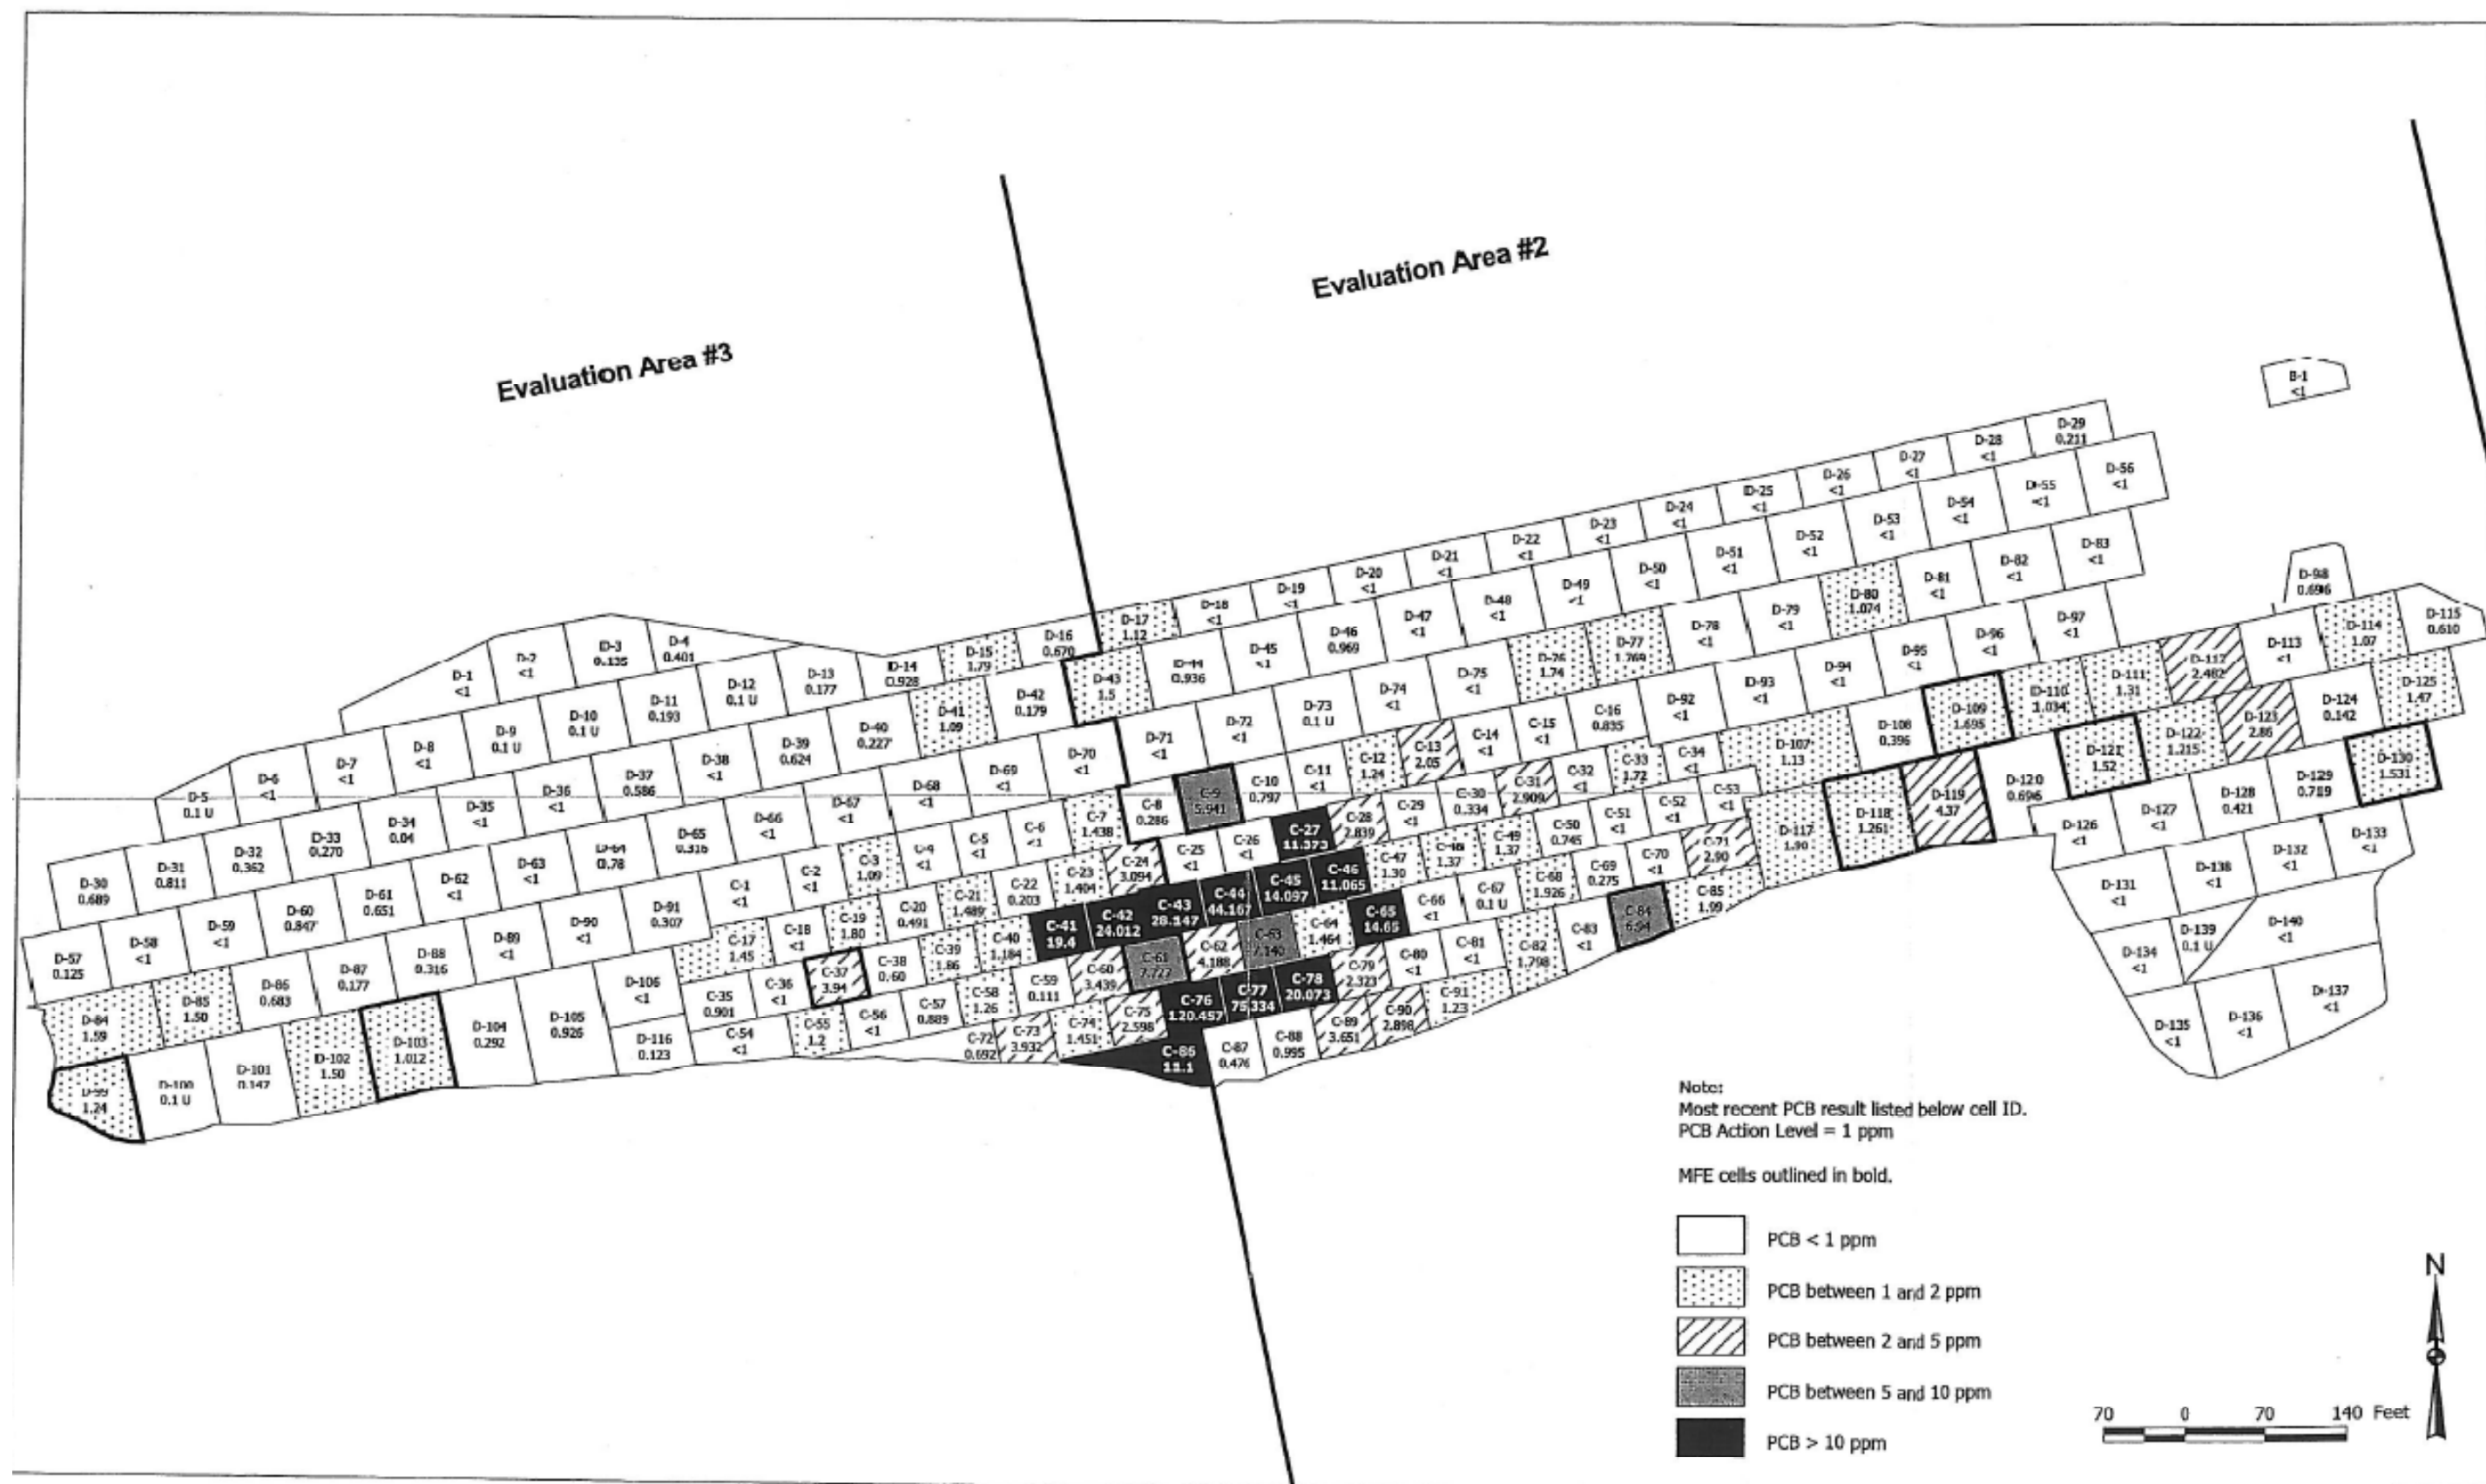
Figure 6-2  
PCBs in Area 2 and 3

The status of all 268 dredge cells at the conclusion of the 2001 dredging program is shown in Table 6-1. The distribution of final verification results within each Evaluation Area (by final PCB concentration (or concentration range) is shown in Table 6-2. Final verification results for PCBs are also plotted on Figures 6-1 (*Evaluation Area 1*) and 6-2 (*Evaluation Areas 2 and 3*).

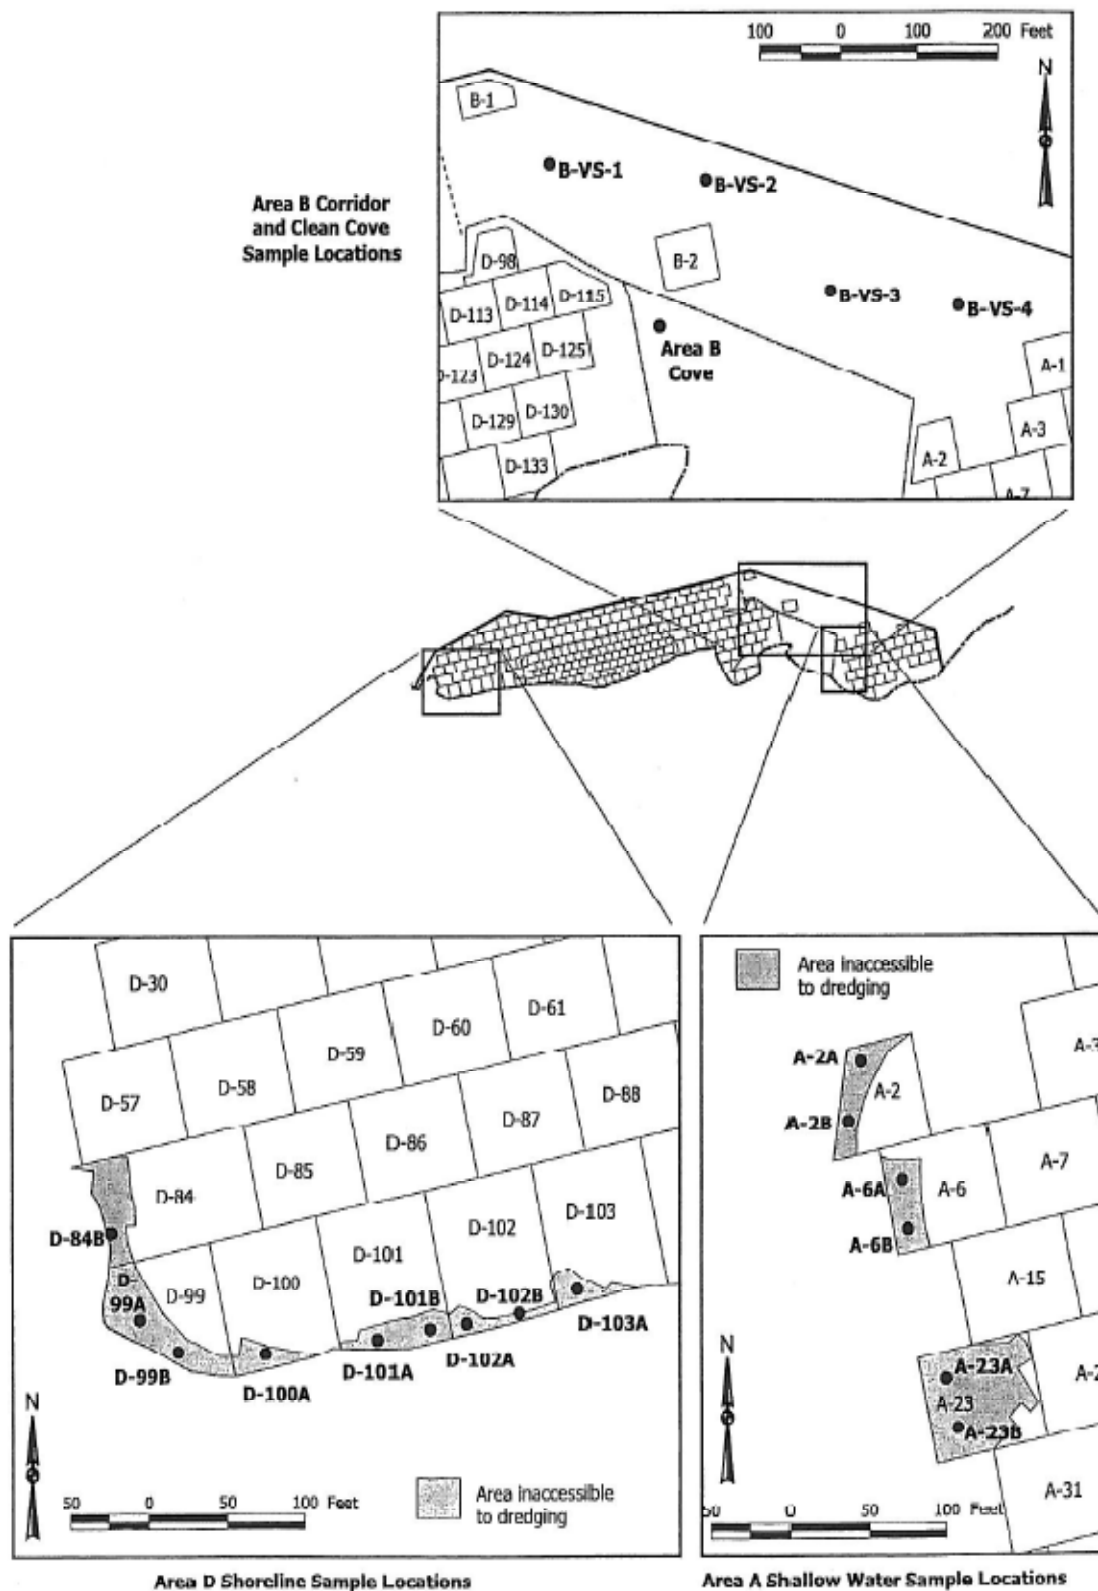
**Figure 6-13**  
**Shoreline cells in Area D and Shallow Water portions of Area A**

Nine shoreline cells in Area D could not be completely dredged due to shallow water depths that prevented movement of the derrick barges close enough to the shore to dredge the entire cell. The locations of these cells, the approximate boundary of the area that was dredged, and sampling locations are shown on Figure 6-13. The undredged portions of the cells were defined as that area between the edge of dredging and the grass line (~156 ft MSL). The undredged area consisted of approximately 5,700 ft<sup>2</sup> (0.13 acres), the target depth of dredging was 8 inches for three cells and 16 inches for three cells, which equates to a volume of 232 yd<sup>3</sup> (Table 6-14).

The shoreline sampling effort in Area D determined that the shoreline portions of five of the six cells did not have PCB contamination above the cleanup goal of 1 ppm. The sixth cell, D-84, had contamination above 1 ppm but the cell was dredged twice more, and both passes extended all the way to the grass line. The final verification sample from this cell identified 1.59 ppm PCBs.
